RESIDENTIAL REPORT(NEW)

410 Mayellen Ave
San Jose, CA 95126

Sandy Kay
JANUARY 26, 2023

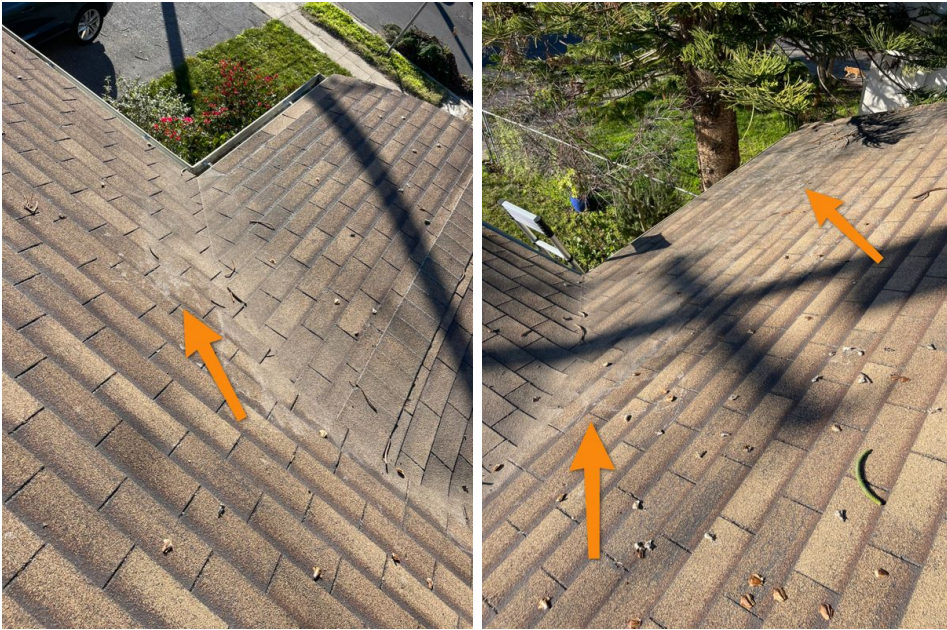
2.2.1 Coverings

DELAMINATION

We observed one or more areas of delamination. Delamination is separation of the surface layer of asphalt. We recommend a qualified roofing contractor make necessary corrections.

Contact a qualified roofing professional.

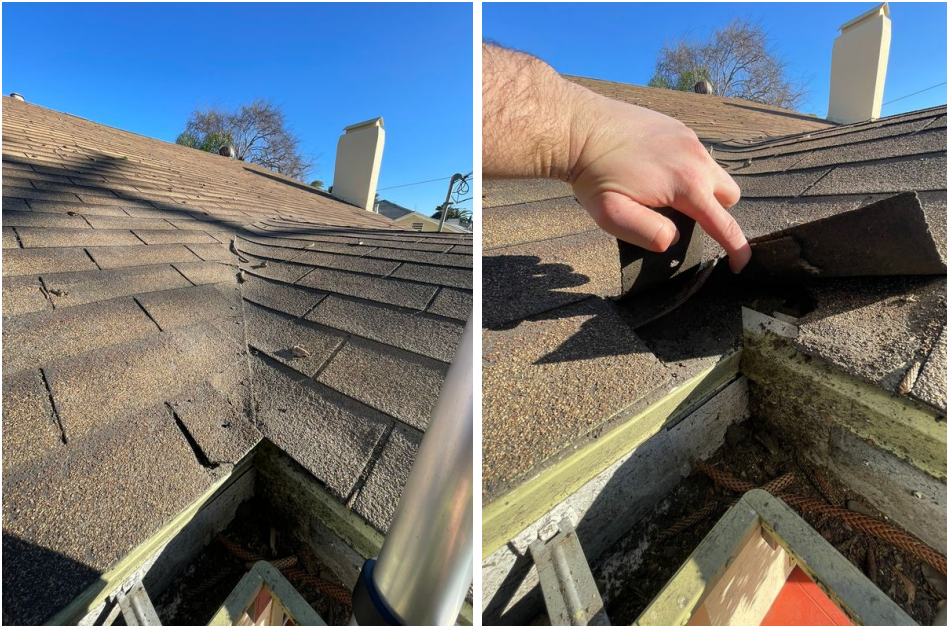
2.2.2 Coverings**SOFT SPOTS ON ROOF**

We observed soft spots on roof. We recommend a qualified roofer make corrections as needed.

Contact a qualified roofing professional.

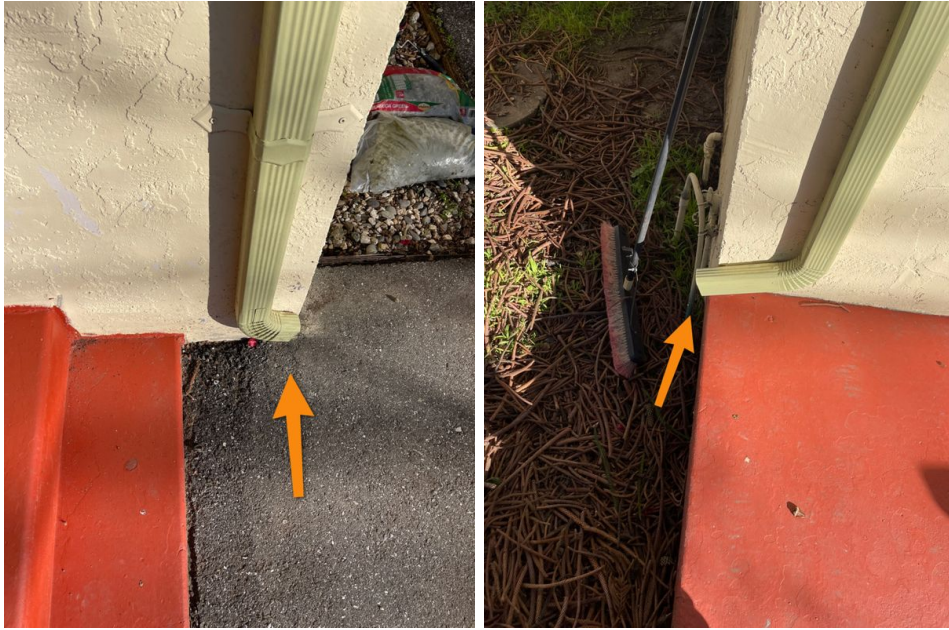
2.3.1 Roof Drainage Systems**DOWNSPOUT DRAIN NEAR HOUSE**

One or more downspout drains are too close to the home's foundation. This can result in excessive moisture in the soil at the foundation, which can lead to foundation/structural movement. We recommend a gutter contractor adjust downspout extensions to drain at least 6 feet from the foundation.

Contact a qualified gutter contractor

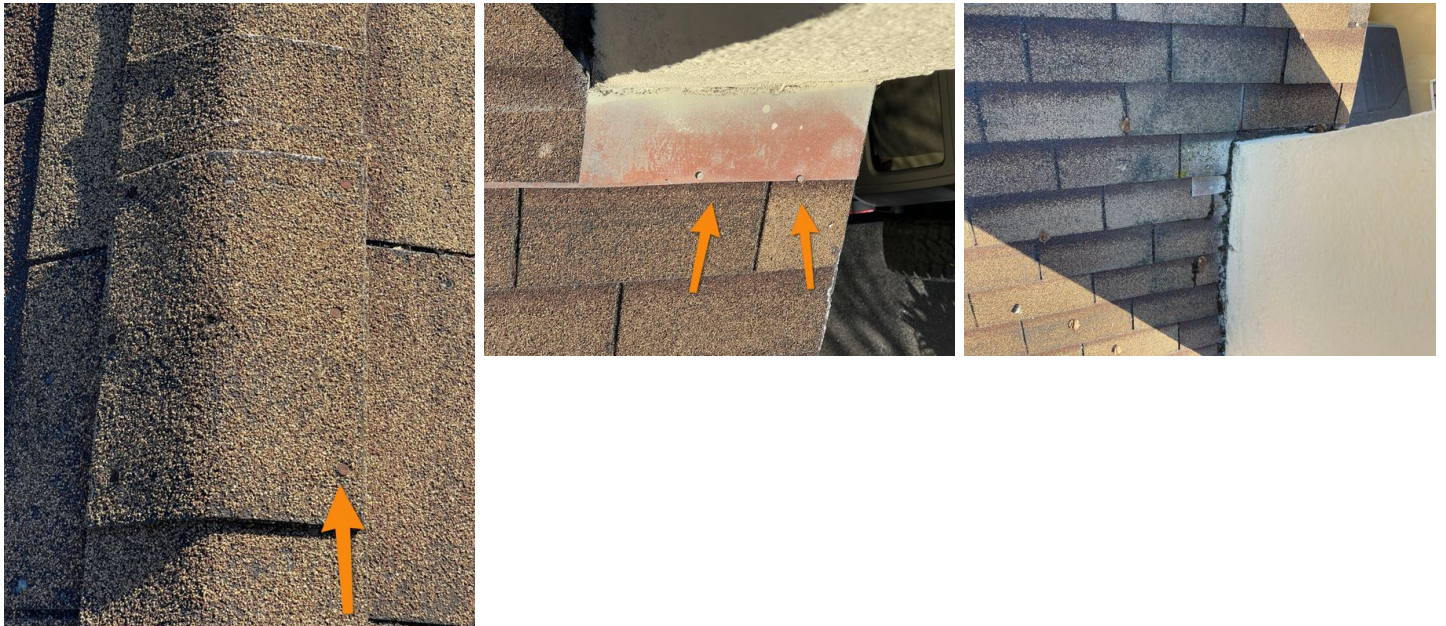
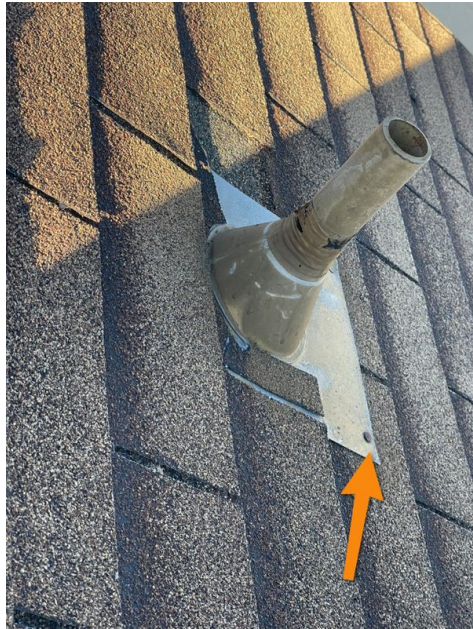
2.4.1 Flashings

FASTENERS NOT SEALED

We observed one or more fasteners that were not sealed. To prevent moisture intrusion, we recommend a qualified roofing contractor make corrections as needed.

Contact a qualified roofing professional.

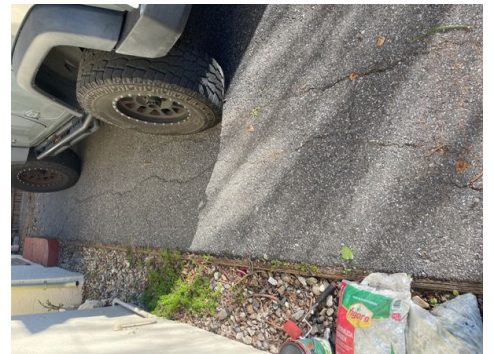
3.2.1 Walkways, Patios & Driveways

DRIVEWAY CRACKING

We observed cracks in one or more areas, which may indicate movement in the soil. We recommend a concrete contractor make corrections as needed.

Contact a qualified concrete contractor.

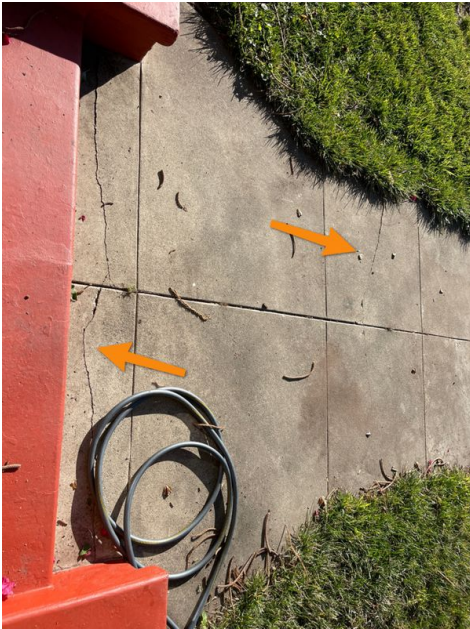
3.2.2 Walkways, Patios & Driveways

WALKWAY CRACKING (MINOR)

Cracking was observed on the front step and one or more walkway bricks mortar has cracked. We recommend referring to a qualified professional seal cracks and make corrections as needed.

Contact a qualified masonry professional.

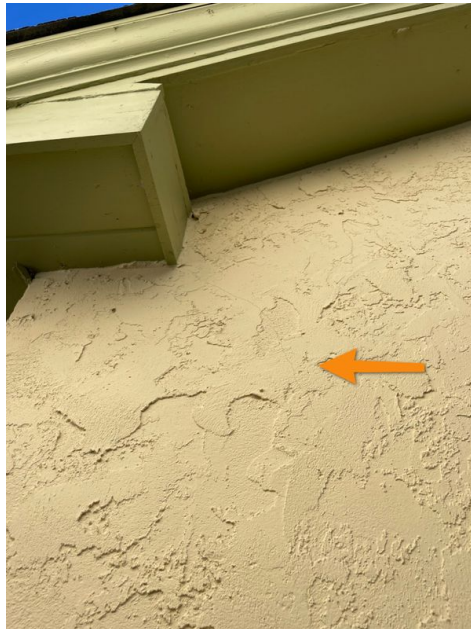
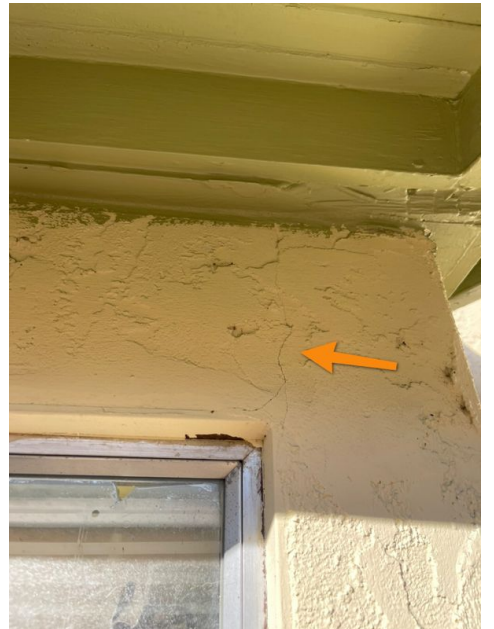
3.3.1 Siding, Flashing & Trim

CRACKING (MINOR)

Cracking was observed at one or more points on the exterior. We recommend sealing/treating cracks by a qualified handyman contractor.

Contact a qualified professional.

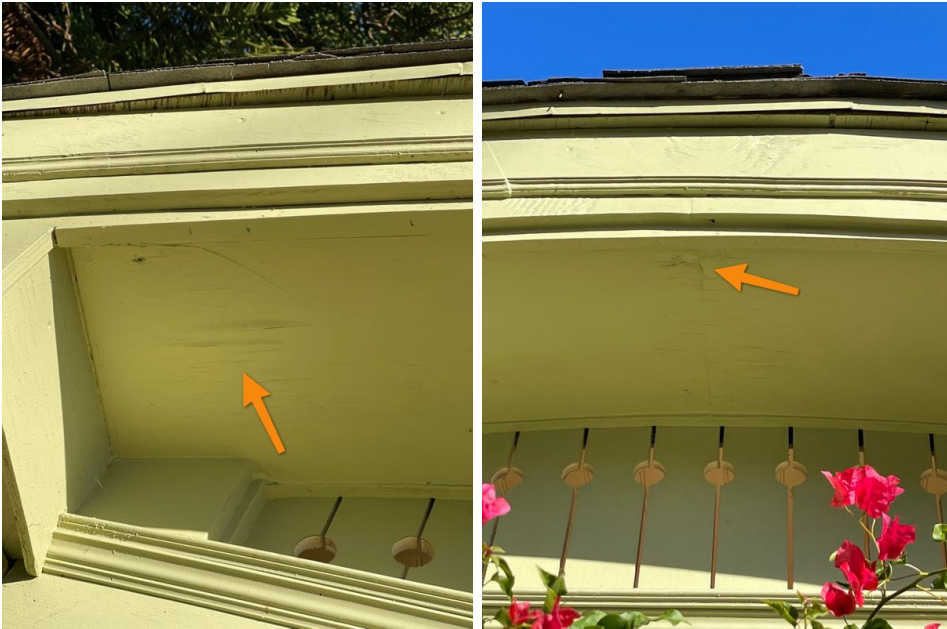
3.5.1 Eaves, Soffits & Fascia

PAIN/FINISH FAILING

We observed paint/finish failing in one or more areas. This can lead to deterioration and rot of the material. We recommend a qualified painting contractor make necessary corrections.

Contact a qualified painting contractor.

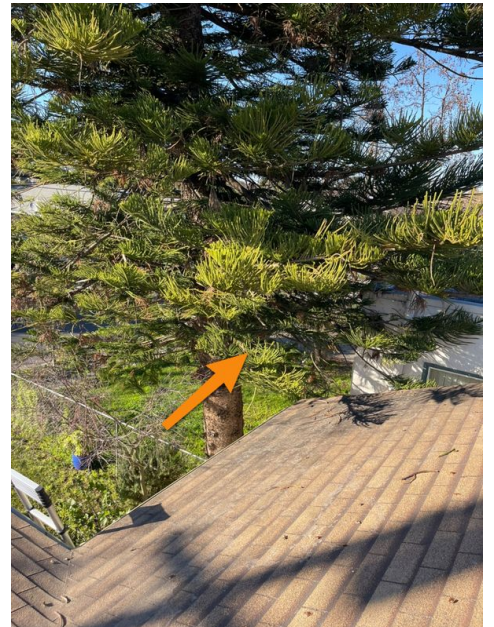
3.6.1 Vegetation, Grading, Drainage & Retaining Walls

TREE OVERHANG

We observed tree overhang above/near roof. This can cause damage to the roof and prevent proper drainage. We recommend a qualified tree service make corrections as needed.

Contact a qualified tree service company.

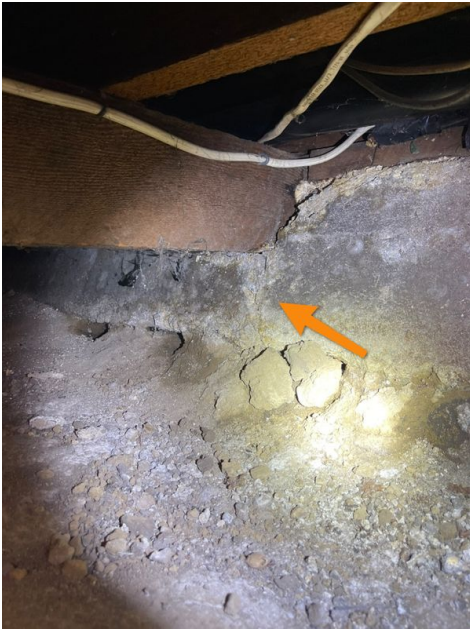
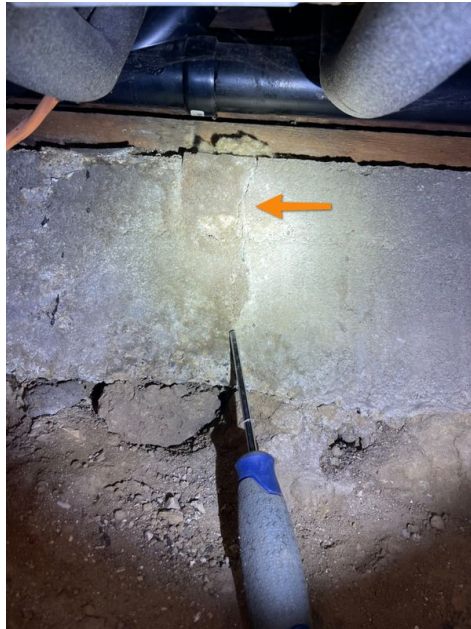
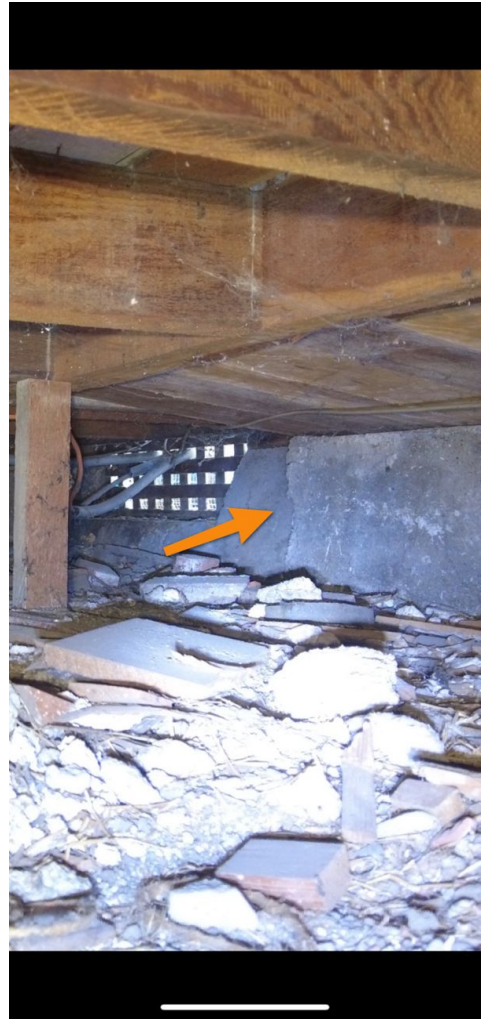
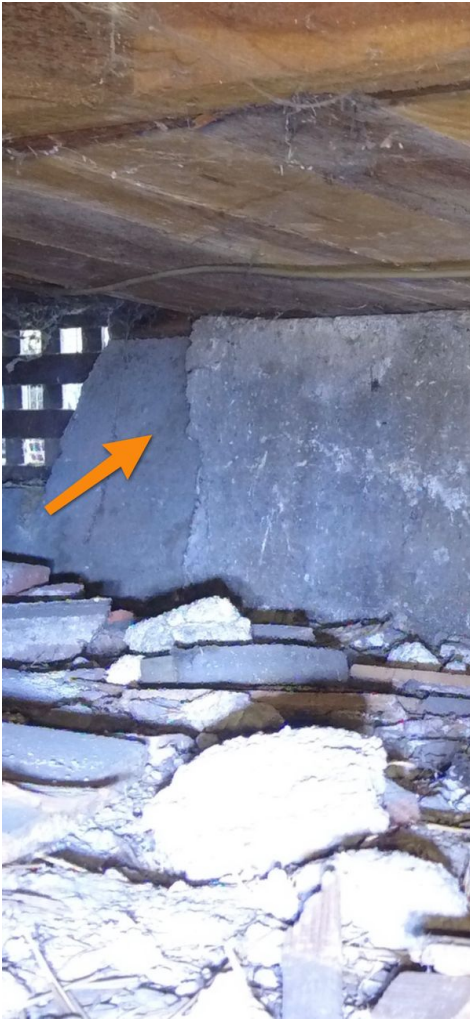
4.2.1 Foundation

FOUNDATION CRACK - MINOR

Minor cracking was noted at the foundation. This is common as concrete ages and shrinkage surface cracks are normal. We recommend monitoring for more serious shifting/displacement.

Recommend monitoring.

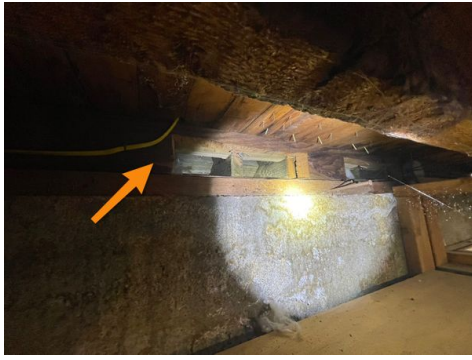
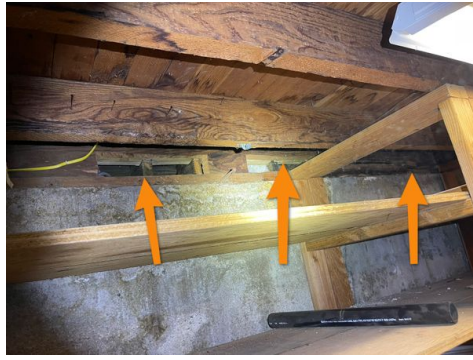
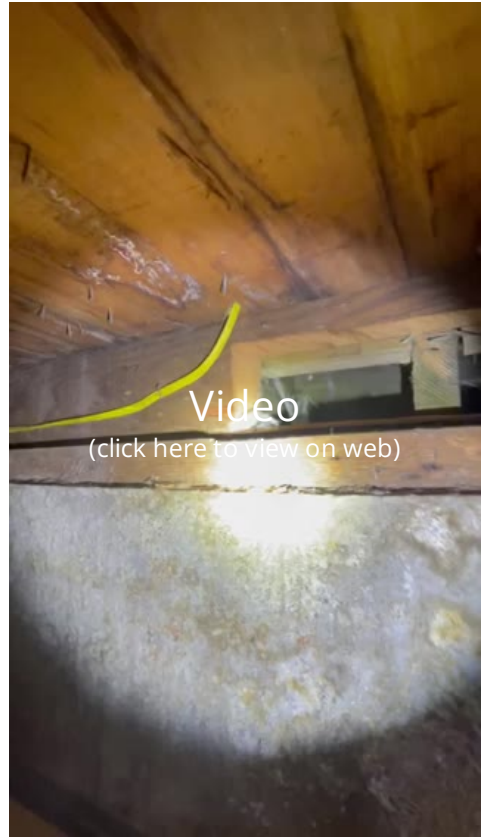
4.2.2 Foundation

NOTCH IN SUPPORT BEAM

We observed a notched out section of a supporting beam and recommend a qualified foundation or handyman contractor to reinforce beam.

Contact a qualified professional.

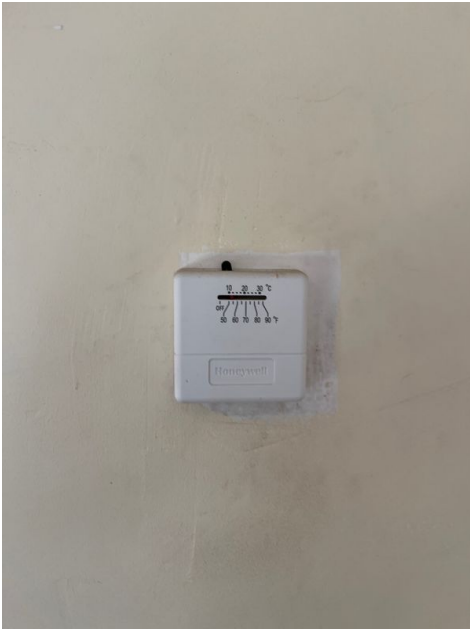
INOPERABLE

Furnace did not turn on using normal operational controls and pilot light was off.

We recommend a qualified HVAC make corrections as needed.

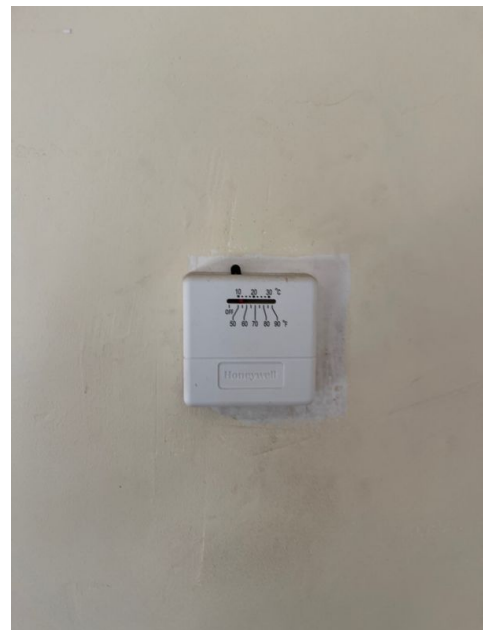
5.3.1 Normal Operating Controls

INOPERABLE

Thermostat was inoperable. Possible replacement needed. This can be a DIY project or refer to a qualified HVAC contractor if needed.

Contact a qualified professional.

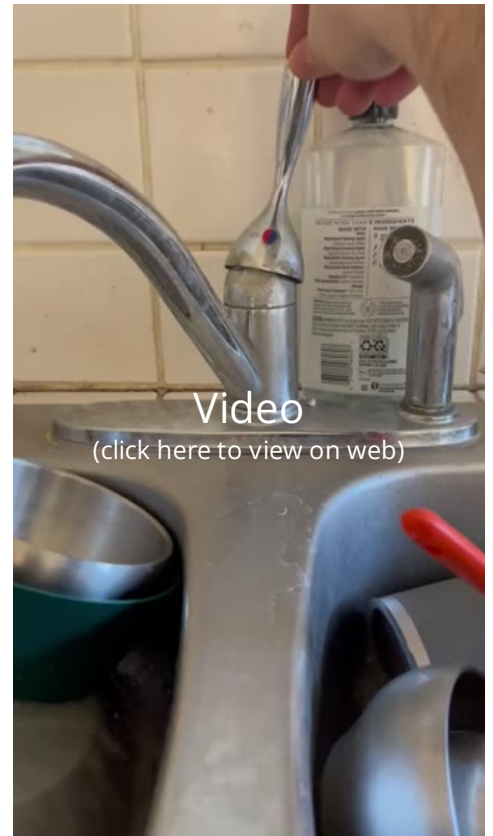
6.3.1 Drain, Waste, & Vent Systems

SINK LOOSE

KITCHEN

We observed the kitchen sink is loose. We recommend a qualified plumber or handyman to make necessary corrections

Contact a qualified professional.

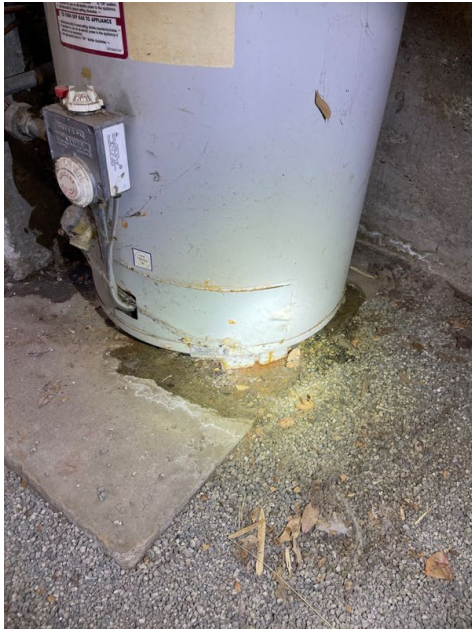
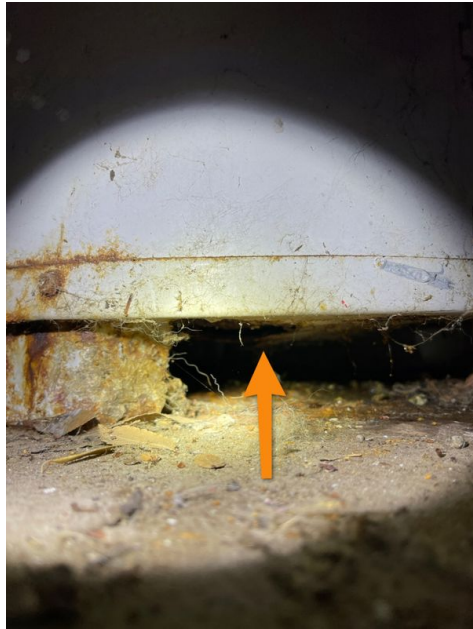
6.5.2 Hot Water Systems, Controls, Flues & Vents

LEAKING

The bottom of the water heater is rusted and leaking. We recommend replacing water heater by a qualified plumbing or HVAC contractor.

Contact a qualified professional.

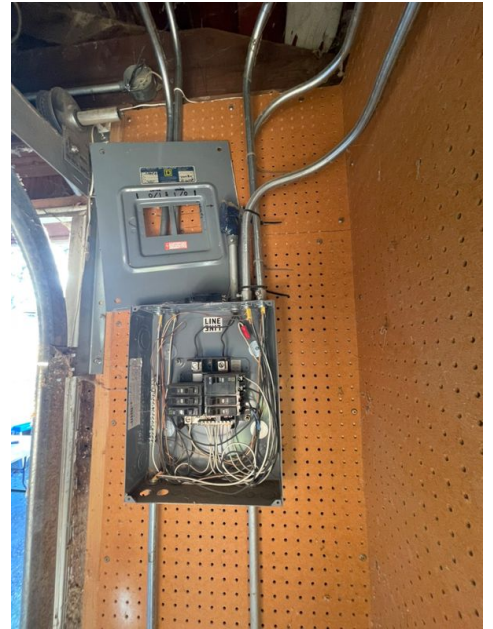
7.3.1 Main & Subpanels, Service & Grounding, Main Overcurrent Device

PANEL NOT SECURED PROPERLY

GARAGE

Panel was not secured properly. We recommend a qualified professional to secure panel.

Contact a qualified professional.

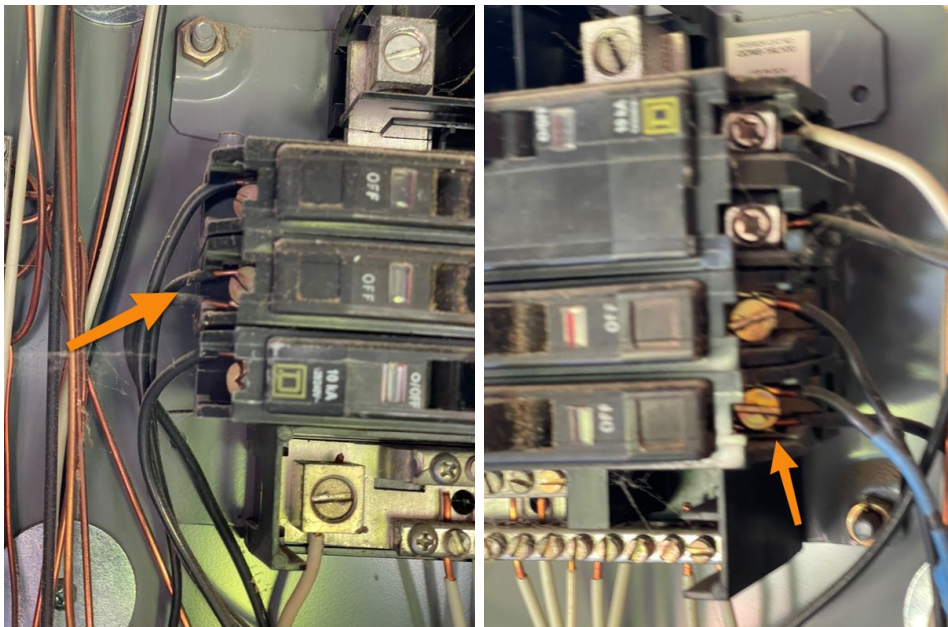
7.3.2 Main & Subpanels, Service & Grounding, Main Overcurrent Device

DOUBLE-TAPPED BREAKERS

GARAGE

We observed a double-tapped breaker. We recommend installing a separate breaker by a qualified electrical contractor.

Contact a qualified professional.

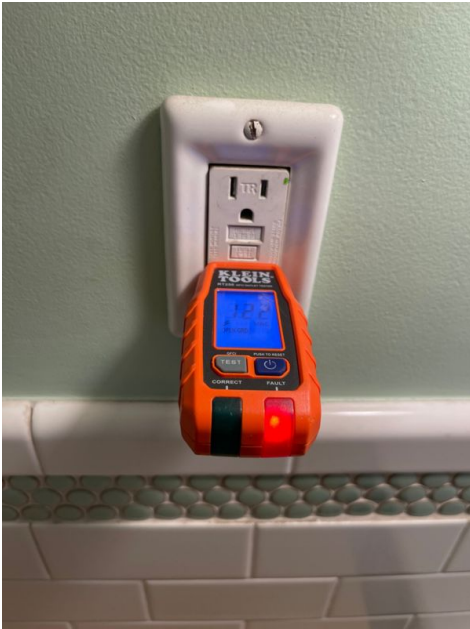
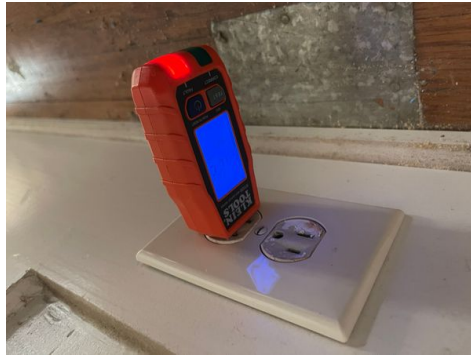
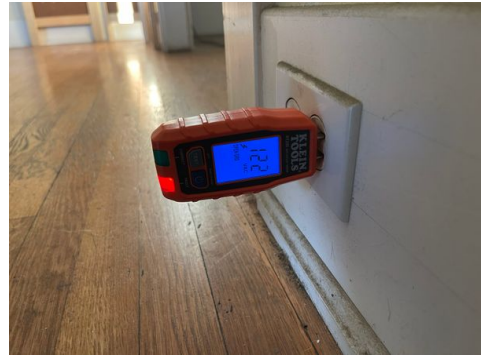
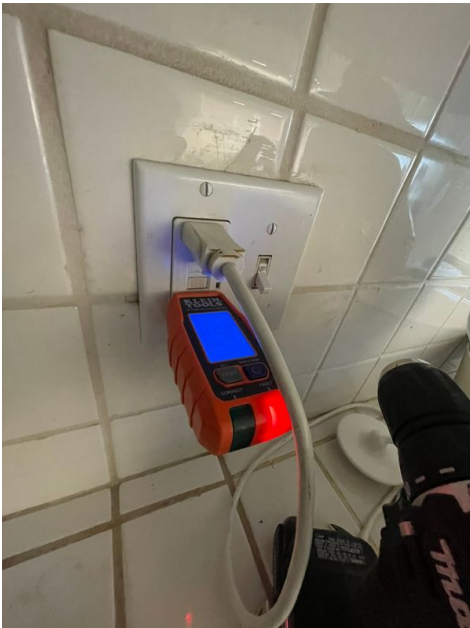
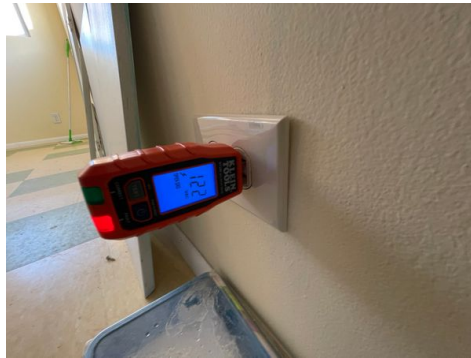
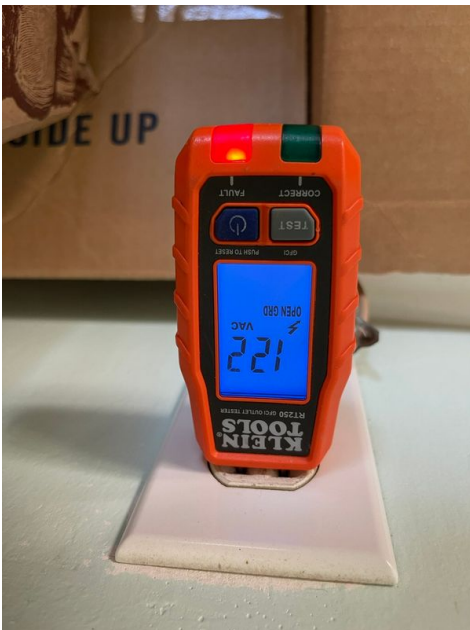
7.5.2 Lighting Fixtures, Switches & Receptacles

OPEN GROUND

We observed one or more outlets with an open ground reading and recommend a qualified electrical contractor make corrections as needed.

Contact a qualified electrical contractor.

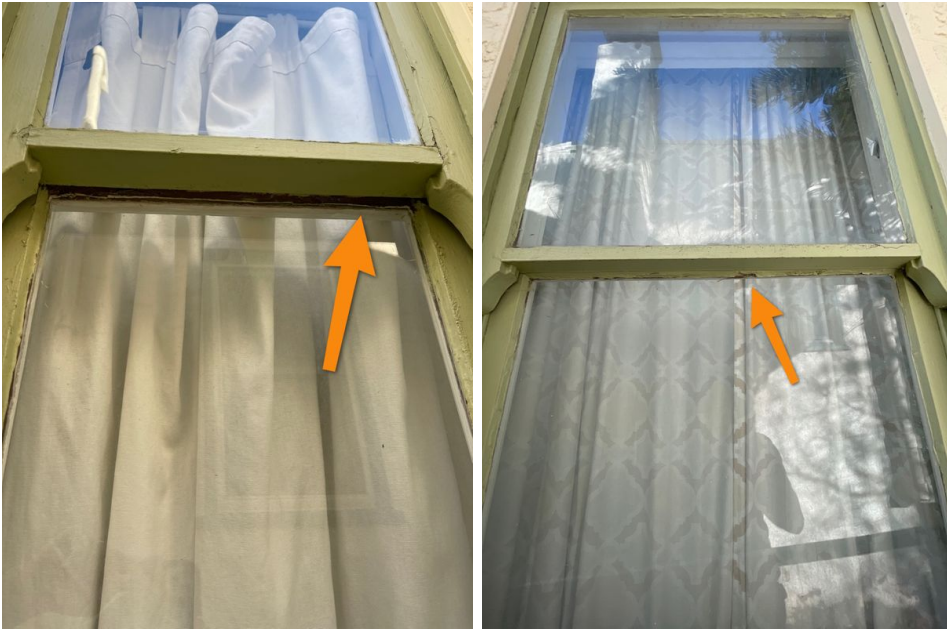
8.3.1 Windows

SEALANT NEEDED

We observed one or more windows with deteriorating sealant, and recommend having it resealed by a qualified handyman or window contractor.

Contact a qualified professional.

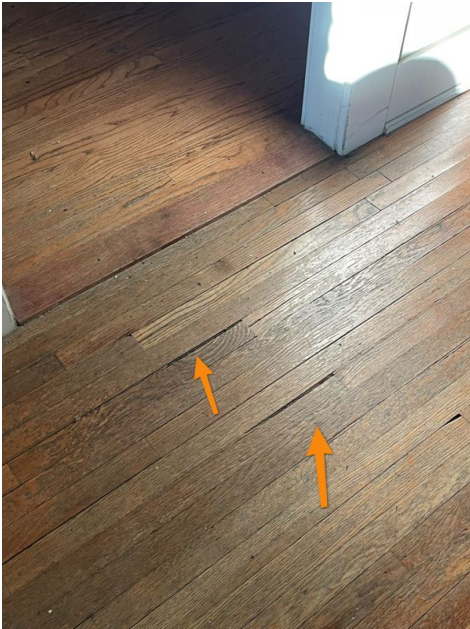
8.4.1 Floors

MODERATE WEAR

Floors in the home exhibited moderate surface wear along major paths of travel. We recommend a qualified flooring contractor evaluate for possible refinish.

Contact a qualified flooring contractor

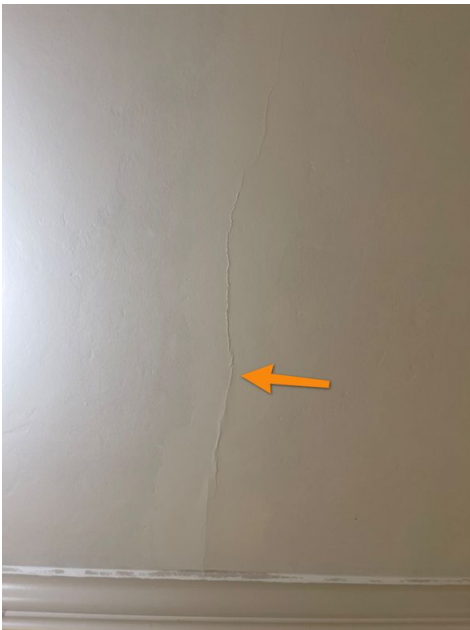
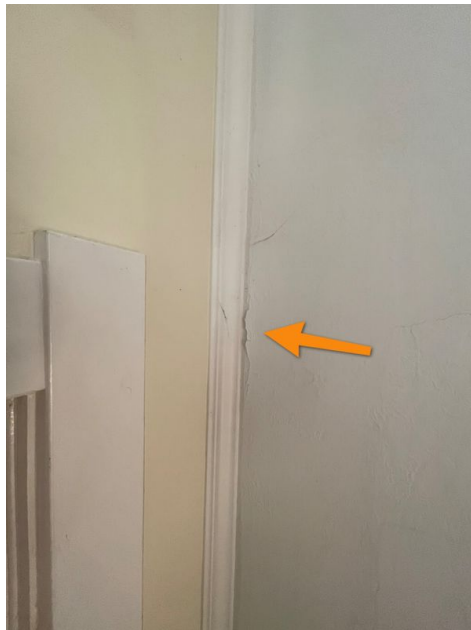
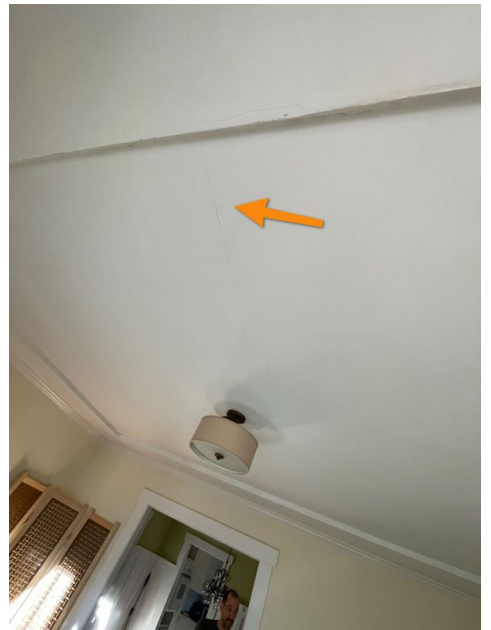
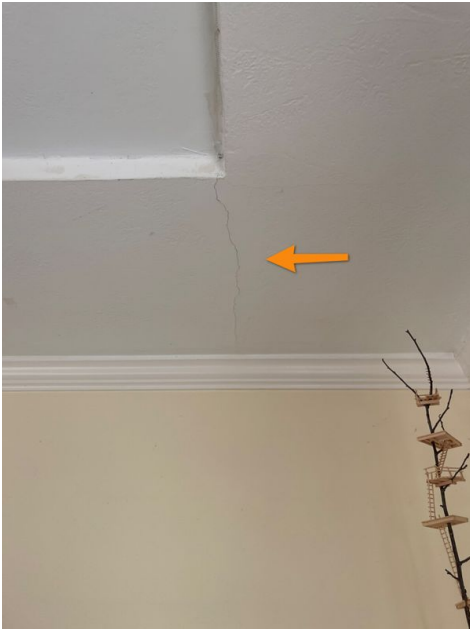
8.6.1 Ceilings

COSMETIC

Contact a qualified professional.

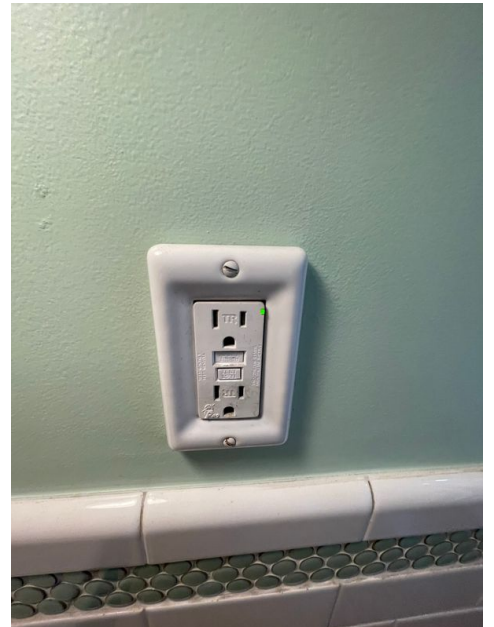
8.7.1 GFCI & AFCI

GFCI OUTLET INOPERABLE

BATHROOM

GFCI outlet would not trip and recommend having it replaced by a qualified handyman or electrician.

Contact a qualified professional.

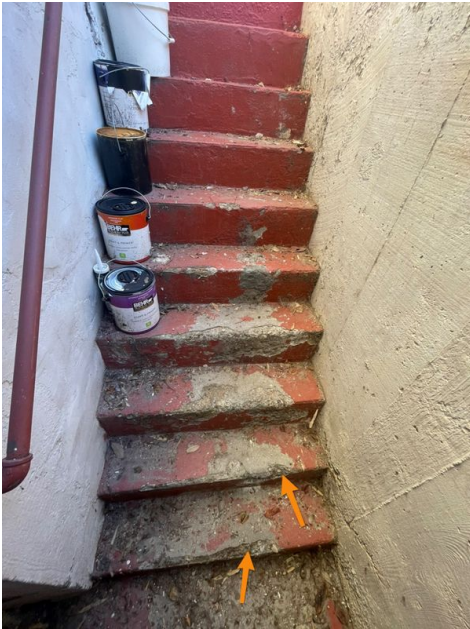
8.9.1 Steps, Stairways & Railings

DAMAGE DETERIORATION

CRAWL SPACE

We observed deterioration of parts of the concrete stair case and recommended a qualified contractor make necessary corrections as needed.

Contact a qualified professional.

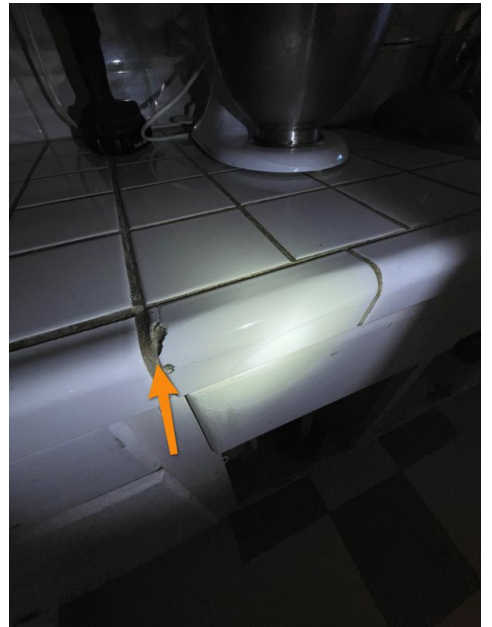
8.11.1 Countertops & Cabinets

COUNTERTOP CRACKED/CHIPPED

Sink countertop is cracked and recommend having it sealed or repaired.

Contact a qualified countertop contractor.

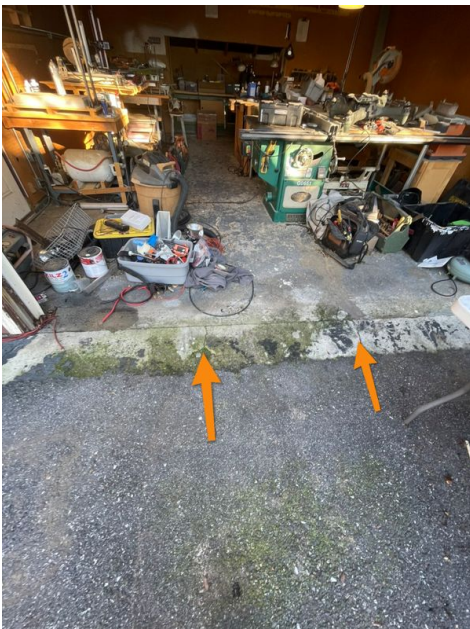
12.3.1 Floor

CRACKING MINOR

We observed one or more crack(s) on garage floor. We recommend referring to a qualified professional to seal or treat cracks.

Contact a qualified professional.
